**Independent Expert Engineering Investigation and Review Panel**

# **Report on Mount Polley Tailings Storage Facility Breach**

**January 30, 2015**

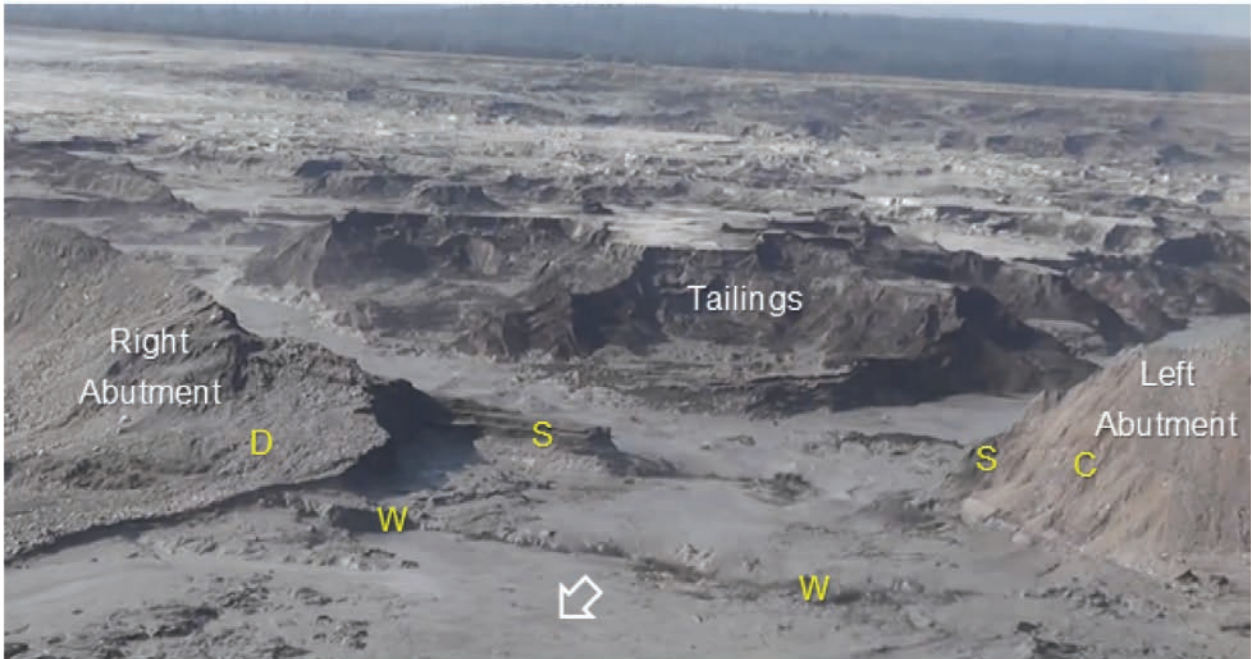
**FIGURE 5.1.1: VIEW LOOKING UPSTREAM THROUGH THE BREACH (ARROW SHOWS DIRECTION OF OUTFLOW)**

The labelled features in **Figure 5.1.1** can be interpreted with reference to the internal zoning of the dam previously provided as **Figure 4.1.1**. On the upstream side of the breach, remnant projections of the dam core (S) can be seen on the left and right abutments. The projection on the right abutment acts like a jetty in directing flow toward the left abutment.

Zone C rockfill (C) is exposed on the left abutment, where it has been eroded by these redirected breach outflows. On the right abutment, the surface of the displaced rockfill (D) was subject to erosional overflow during earlier stages of breach development. It was subsequently protected from erosional undercutting in the main channel by the projecting core remnant and eddies that developed downstream.

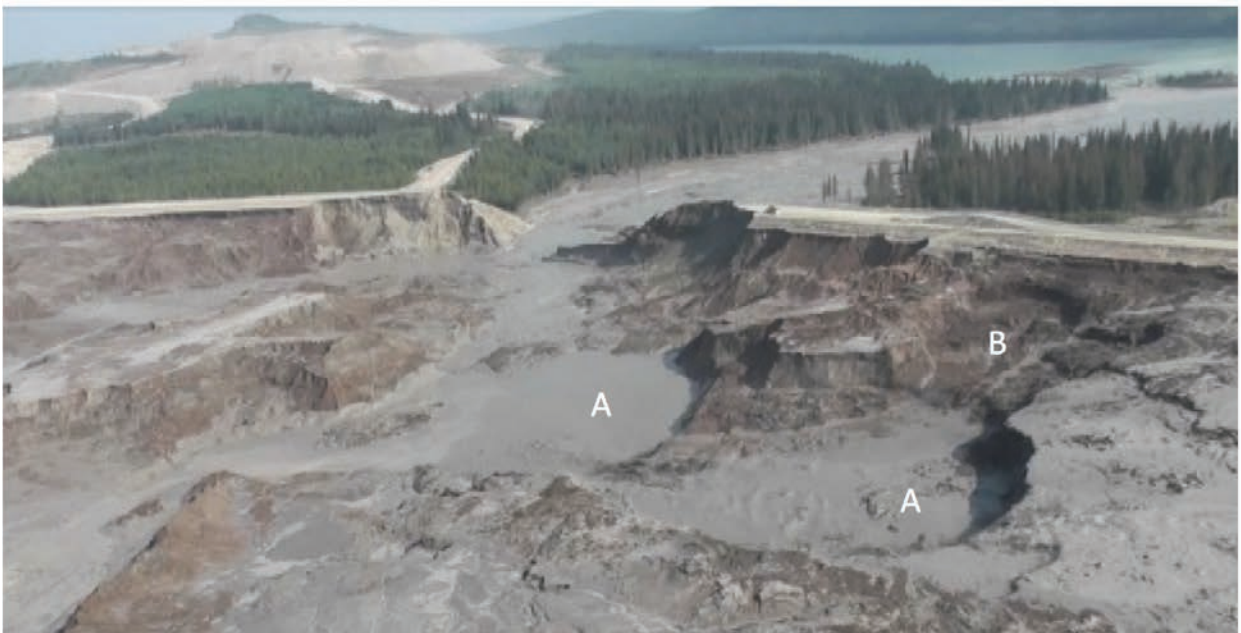
**FIGURE 5.1.2: VIEW LOOKING DOWNSTREAM SHOWING UPSTREAM SIDE OF DAM AND REMAINING TAILINGS**

At this point, two major flow channels have developed within the impoundment that converge at the upstream entry to the breach. In the distance (centre left), one of these can be seen flowing along the left side of the dam. As it did so, it eroded away the supporting tailings. This caused the upstream side of the dam to collapse, leaving the prominent near-vertical face. These structural effects are again best appreciated with reference to **Figure 4.1.1**.

Conditions adjacent to the right side of the dam illustrate how the combined action of fluvial erosion and tailings flowsliding produced similar effects. The active flowslide (B) has left a semicircular headscarp that is progressing back and undermining the Zone U tailings supporting the upstream side of the dam core. Arcuate headscarps of earlier flowslides (A) have captured and concentrated overland flows from surface water remaining in the impoundment. The resulting cascades readily transport flowslide debris, while at the same time causing backward erosion of the headscarps by scour within their terraced plunge pools.

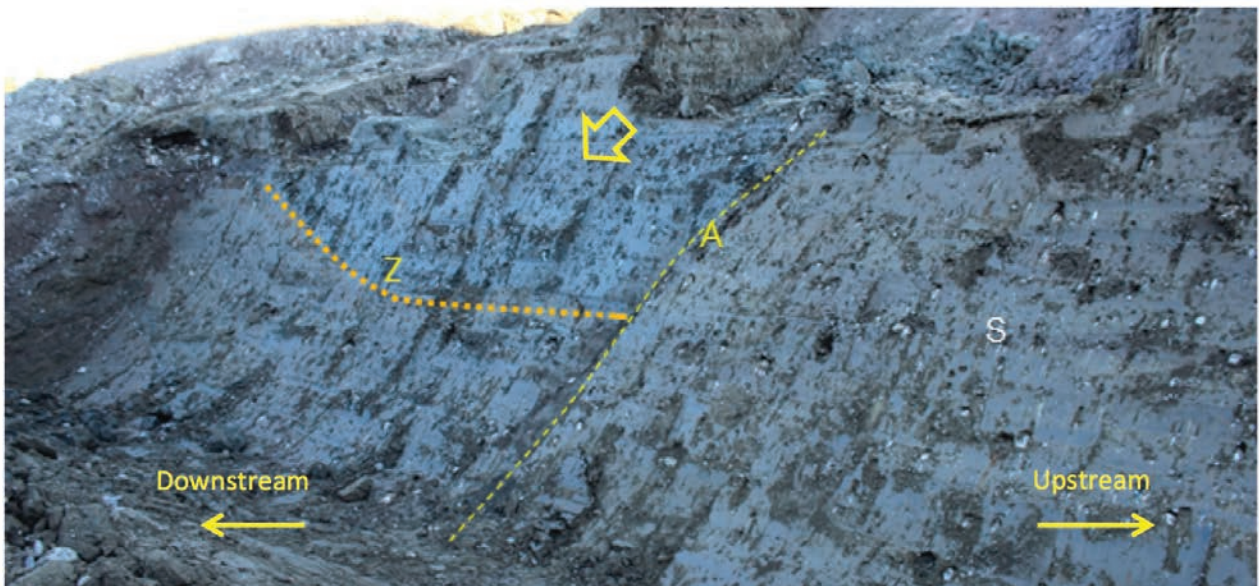
**FIGURE 5.1.3: SHEAR SURFACE THROUGH REMNANT DAM CORE (ARROW INDICATES DIRECTION OF DOWNDROP)**

The surface trace and 3-D orientation of the shear are shown on the core remnant in Figure 5.1.4, with a dip angle and direction as indicated.

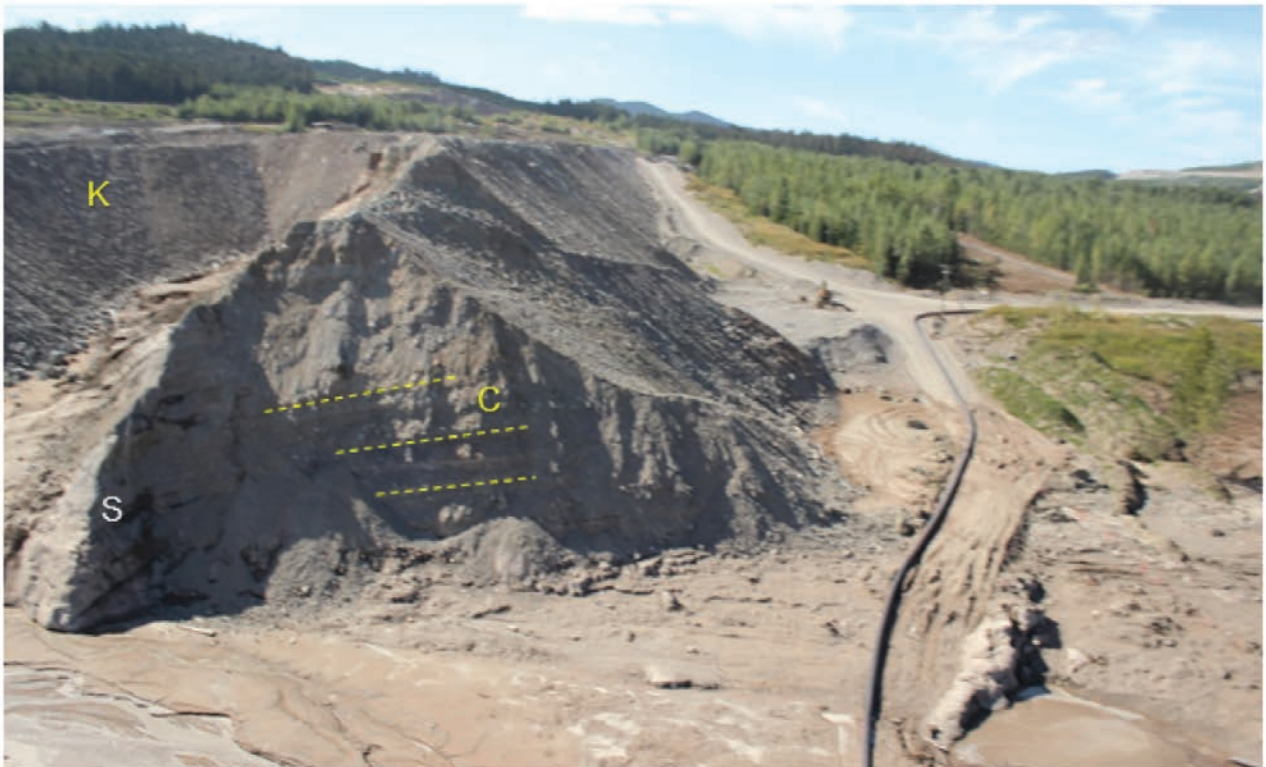
**FIGURE 5.1.5: APPARENT BEDDING ROTATION ON LEFT ABUTMENT OF BREACH (SEPT. 4, 2014 PHOTO)**

Other artifacts of foundation sliding are evident elsewhere. As indicated in **Figure 5.1.5**, lift lines in the Zone C rockfill on the left abutment (C) are tilted at an inclination of 7° to 10°, with corollary inclinations on the right abutment of 5° to 14°. Also shown in **Figure 5.1.5** are the Zone S core (S), with a containment dike (K) under construction in the background. Scarps higher on the left abutment were produced by post-sliding downdrop of large slump blocks into the breach due to erosional undercutting at foundation level.

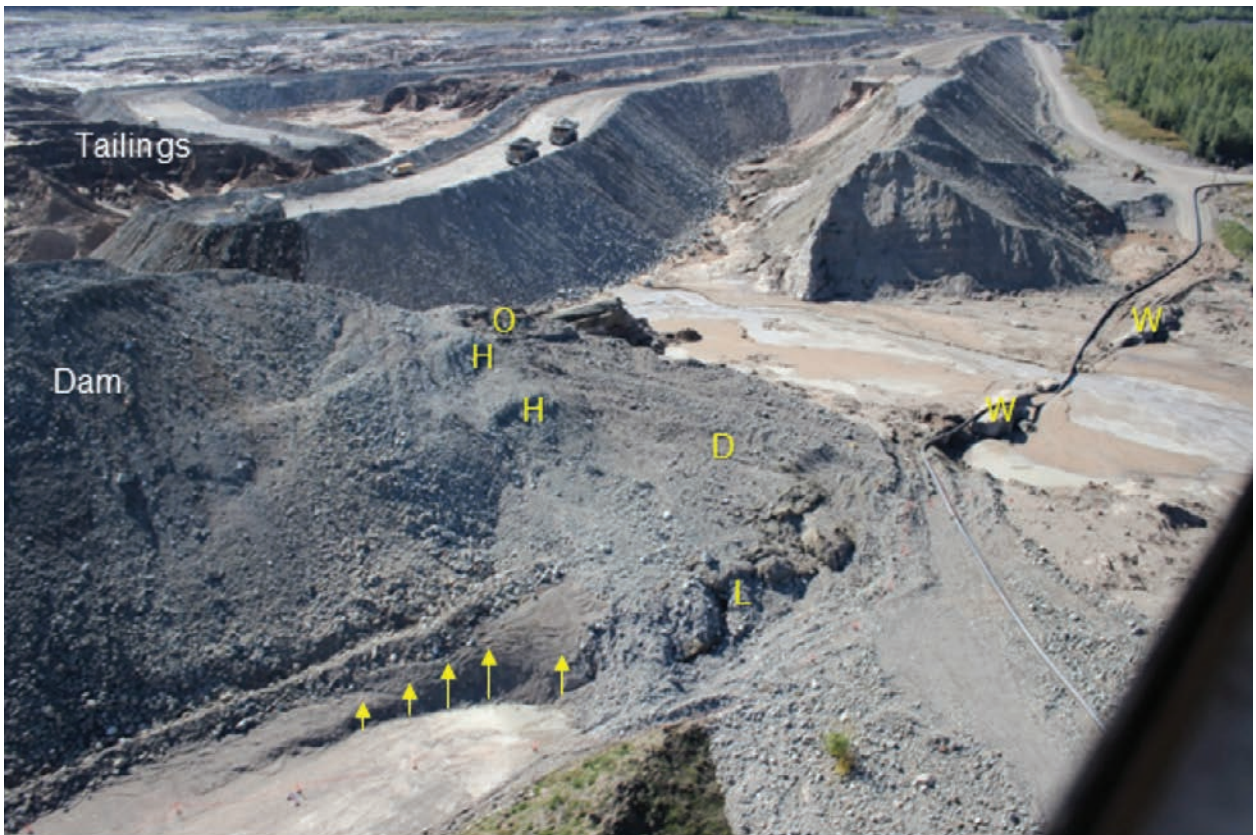
**FIGURE 5.1.6: SLIDING-RELATED FEATURES AT RIGHT ABUTMENT (SEPT. 4, 2014 PHOTO)**

**Figure 5.1.6** shows the right abutment, with the left abutment in the background. Noteworthy features include open cracks (O) and headscarps (H) at higher elevations. At the downstream toe, upthrust of foundation till (L) ranging from 2.8 m to 3.5 m has occurred along an alignment collinear with the whaleback (W).

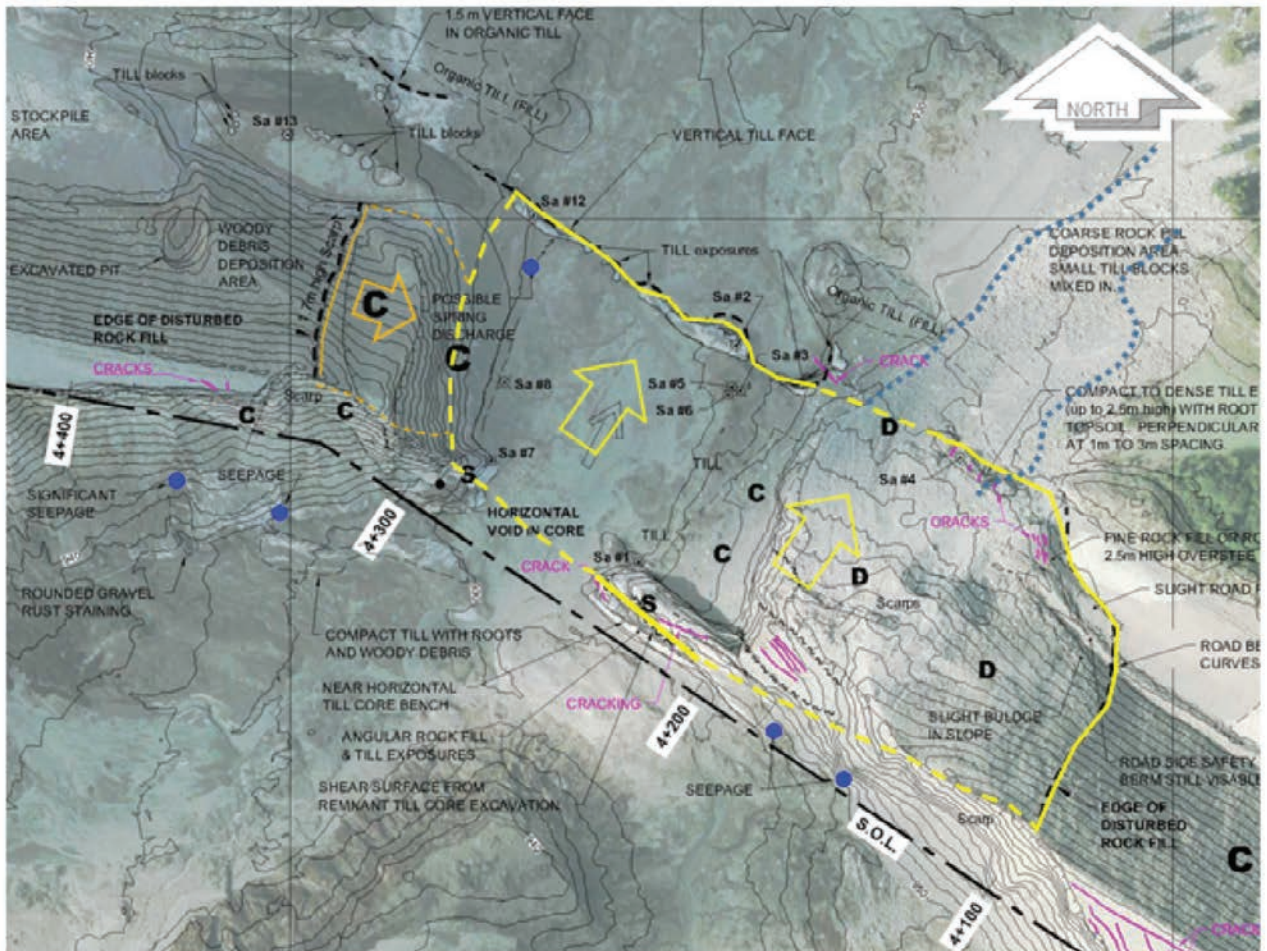
**FIGURE 5.1.7: PLAN SHOWING DIRECTION AND EXTENT OF MASS MOVEMENTS**

Surface investigations delineate the limits of foundation sliding given in **Figure 5.1.7**, with the solid and dashed yellow lines indicating observed and inferred boundaries, respectively. These are superimposed on the post-failure orthophoto and contours to show the extent of mass movement in relation to the breach. Arrows indicate directions of movement from surface observations.

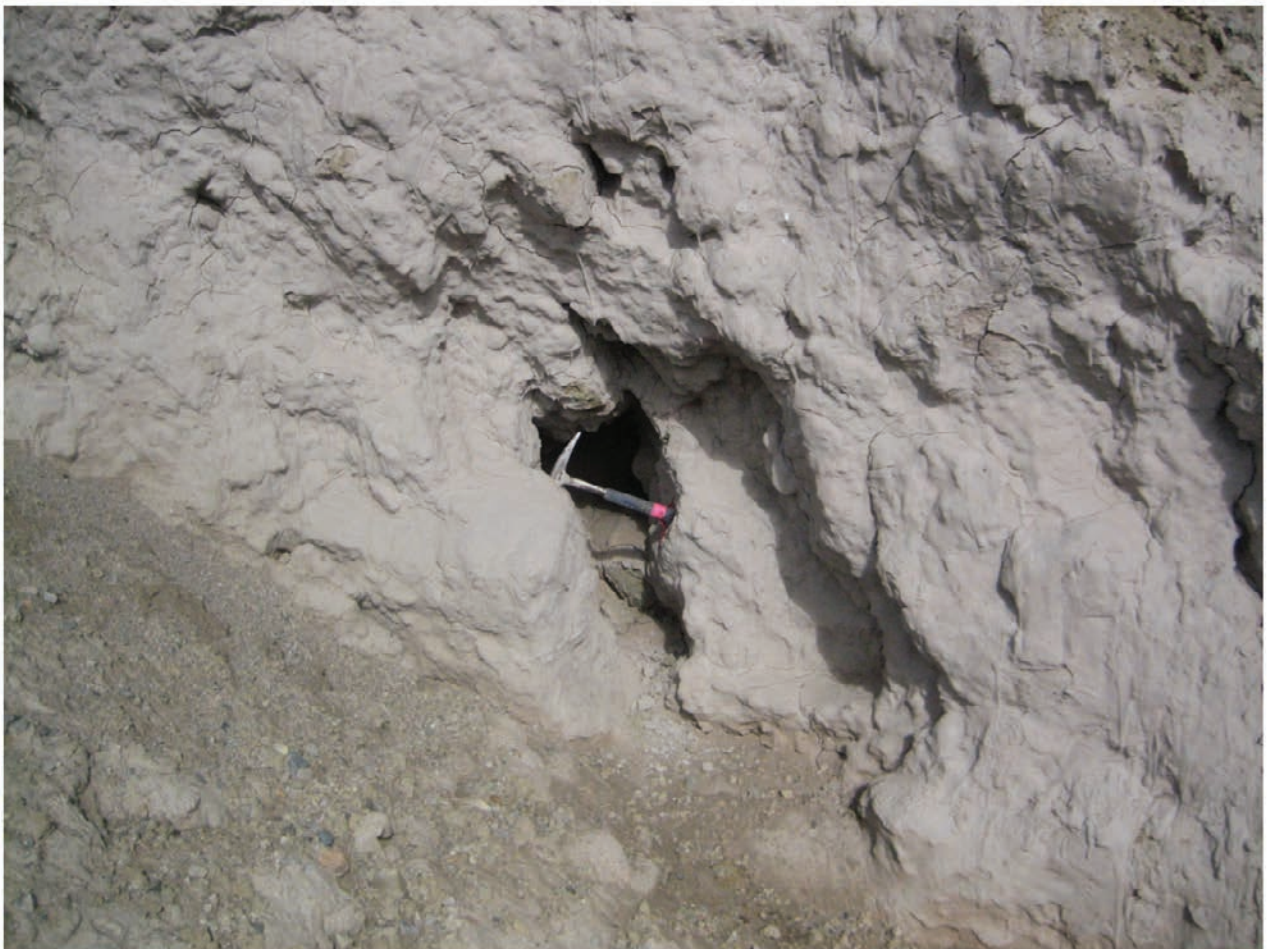
**FIGURE 5.1.8: VOID ON UPSTREAM SIDE OF LEFT ABUTMENT**

Additionally, Zone F filter material immediately downstream from the core was sampled in the right abutment excavation. Gradation data show that none of these samples met filter criteria that would have enabled them to prevent transport of fines from the till. Together, these factors suggest internal erosion as the likely cause of the left abutment void.

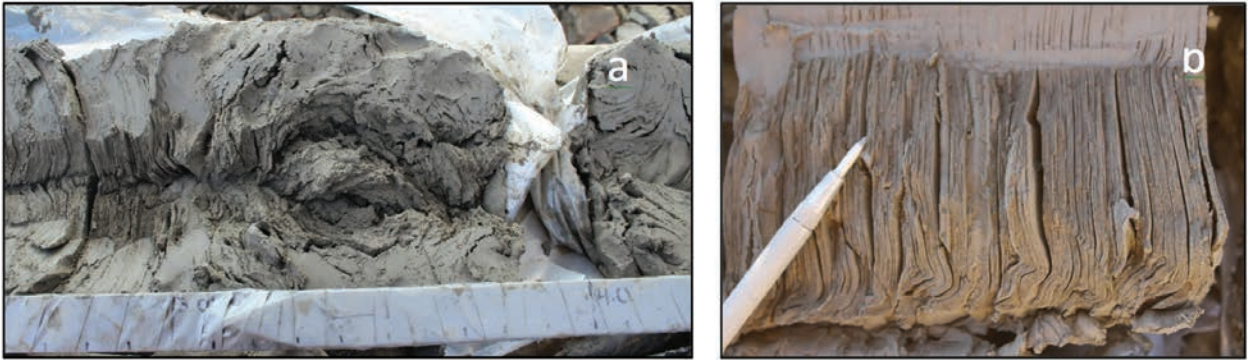
**FIGURE 5.2.8 UPPER GLU (a) INSIDE THE BREACH, (b) OUTSIDE THE BREACH**

The thinly laminated, planar varving outside the breach contrasts sharply with the contorted and folded laminations within it. This is consistent with shearing of the Upper GLU having occurred within the breach.

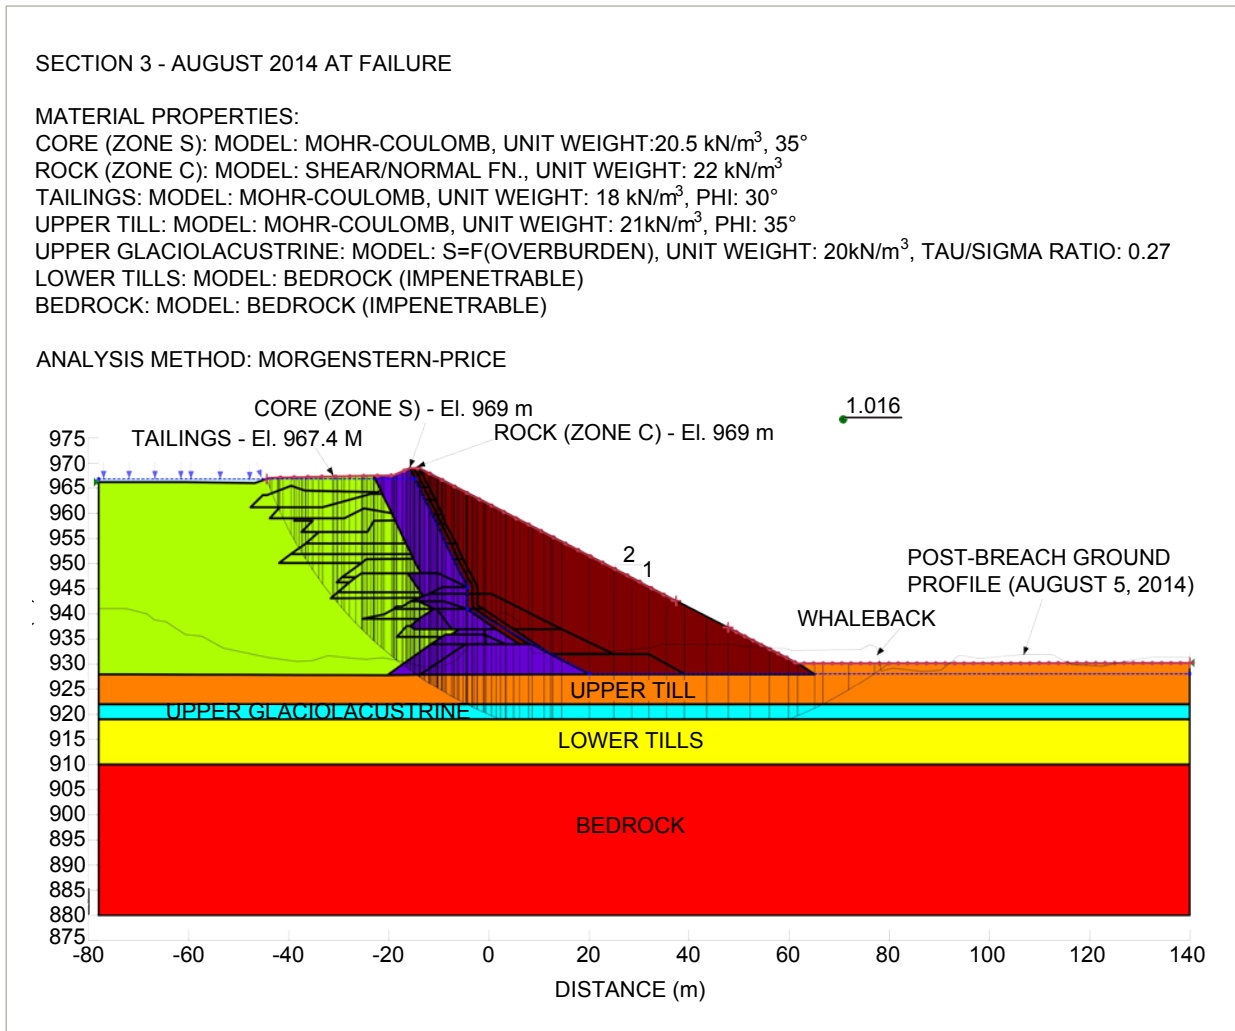
**FIGURE 6.5.1: 2-D LIMIT EQUILIBRIUM 2H:1V SLOPE TO ELEVATION 969 M (UNDRAINED STRENGTH RATIO 0.27, HIGH WATER TABLE, FS 1.02)**

Hence, the omissions associated with site characterization may be likened to creating a loaded gun. Notwithstanding the large number of experienced geotechnical engineers associated with the TSF over the years, the existence of this loaded gun remained undetected.
