**Independent Expert Engineering Investigation and Review Panel**

# **Report on Mount Polley Tailings Storage Facility Breach**

**January 30, 2015**

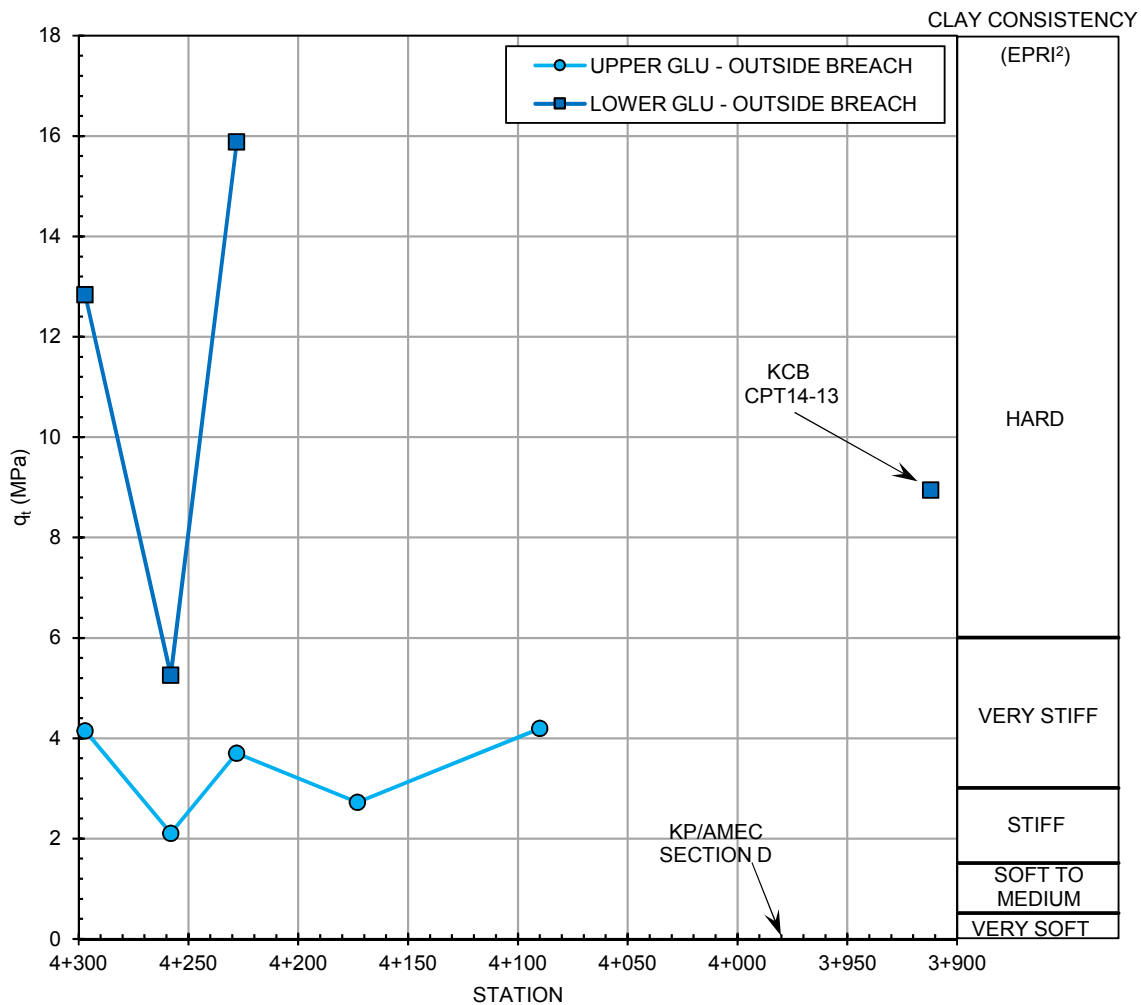
**FIGURE 5.2.4: LONGITUDINAL VARIATION IN CPT TIP RESISTANCE**

Secondly, CPT tip resistance in the two units is distinctly different. **Figure 5.2.4** shows that tip resistance  $q_t$  for the Upper GLU is less than one-half of that for the Lower GLU across the breach area. Using  $q_t$  as a measure of clay consistency, the Upper GLU classifies as stiff to very stiff, while the Lower GLU classifies as very stiff to hard.

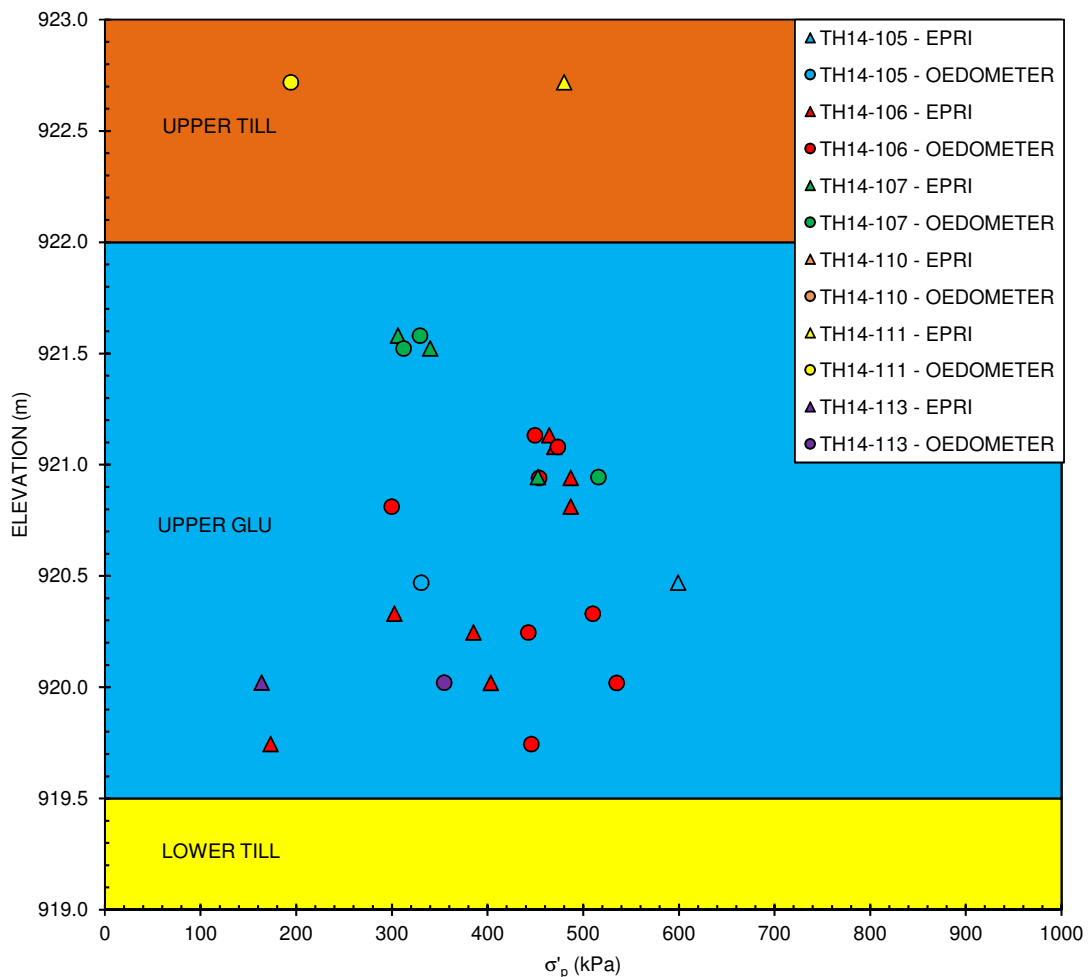
**FIGURE 5.3.3: PRECONSOLIDATION PRESSURE WITH ELEVATION**

Preconsolidation pressure can also be inferred from the CPT testing conducted as part of the Panel's site investigation. Again, only modest preconsolidation stresses have been determined. A comparison between the results obtained from the field tests with those obtained from the oedometer tests is shown in **Figure 5.3.3**, and the agreement is acceptable. As the embankment was raised to a stress level beyond the preconsolidation stresses, the underlying GLU reverted to normally consolidated behaviour.

**As the embankment was raised to a stress level beyond the preconsolidation stresses, the underlying GLU reverted to normally consolidated behaviour.**

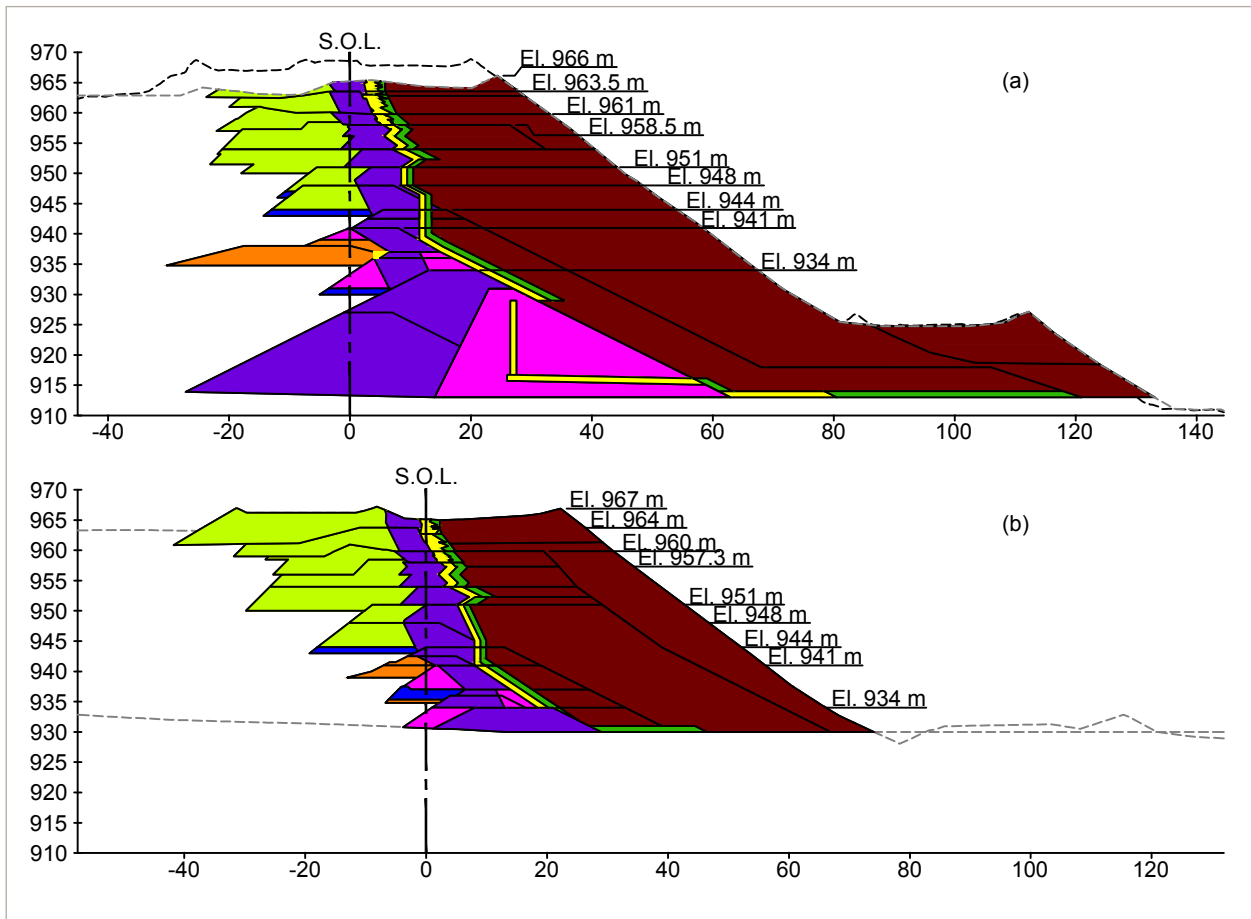
**FIGURE 5.4.10: DAM CONFIGURATION ON AUGUST 3, 2014. (a) MAIN EMBANKMENT (b) PERIMETER EMBANKMENT AT BREACH SECTION**

The specifics of the failure were triggered by the construction of the downstream rockfill zone at a steep slope of 1.3 horizontal to 1.0 vertical. Had the downstream slope in recent years been flattened to 2.0 horizontal to 1.0 vertical, as proposed in the original design, failure would have been avoided. The slope was on the way to being flattened to meet its ultimate design criteria at the time of the incident.

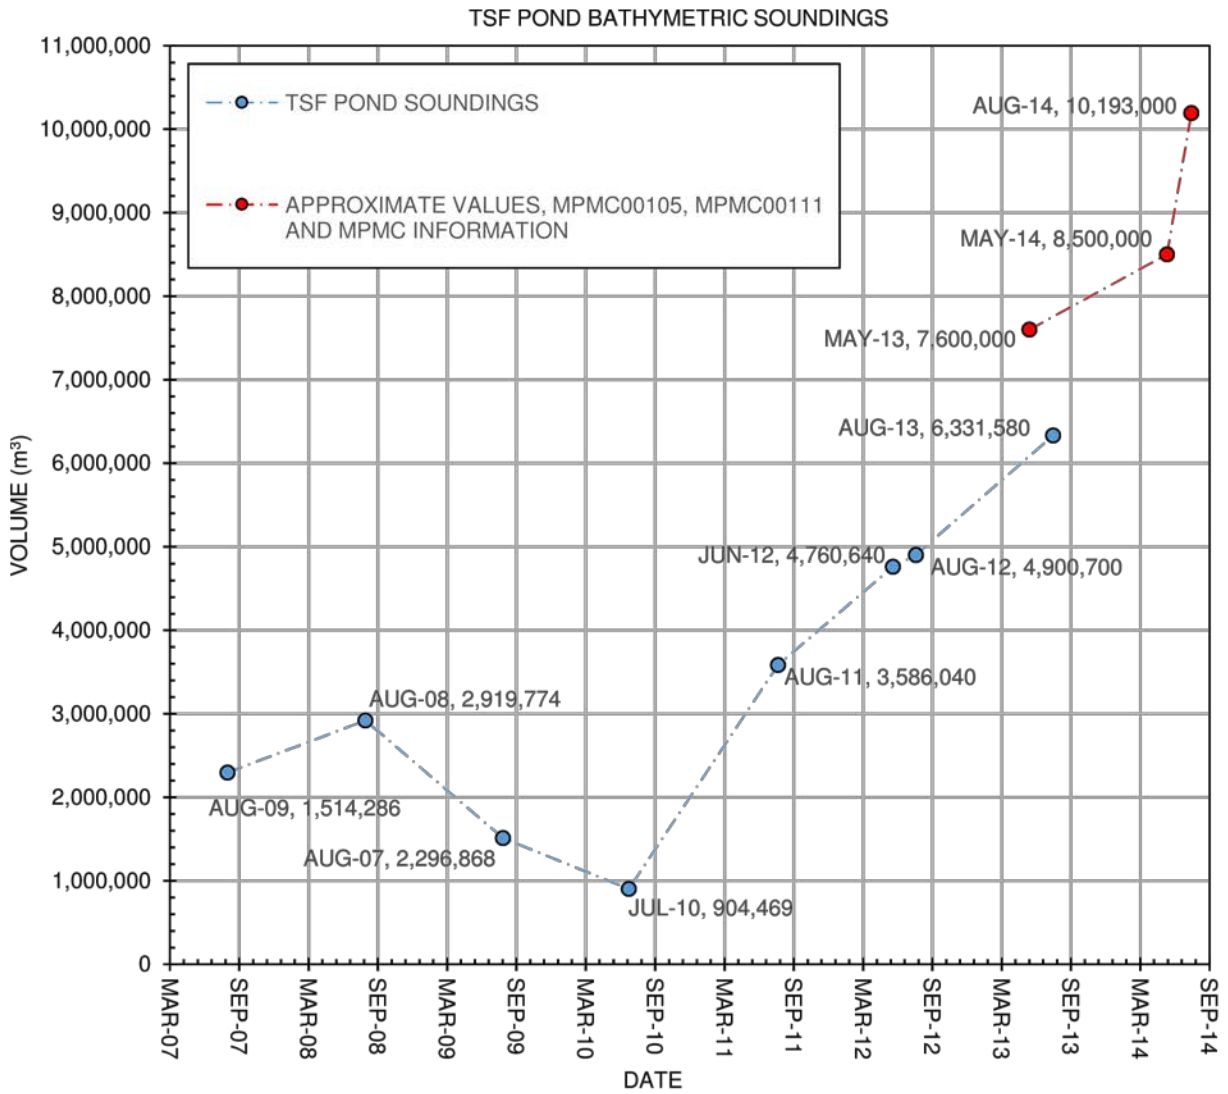
FIGURE 5.6.1: WATER ACCUMULATION IN TSF

MPMC was aware of the water surplus conditions at the start of Phase 2 operations. The pond volumes in **Figure 5.6.1** show that the last number of embankment raises were necessary to store water and not necessarily much higher tailings production. It is not clear to the Panel why it took so long to design and implement a water treatment strategy that would provide for a significant reduction in the amount of surplus water stored on the TSF.

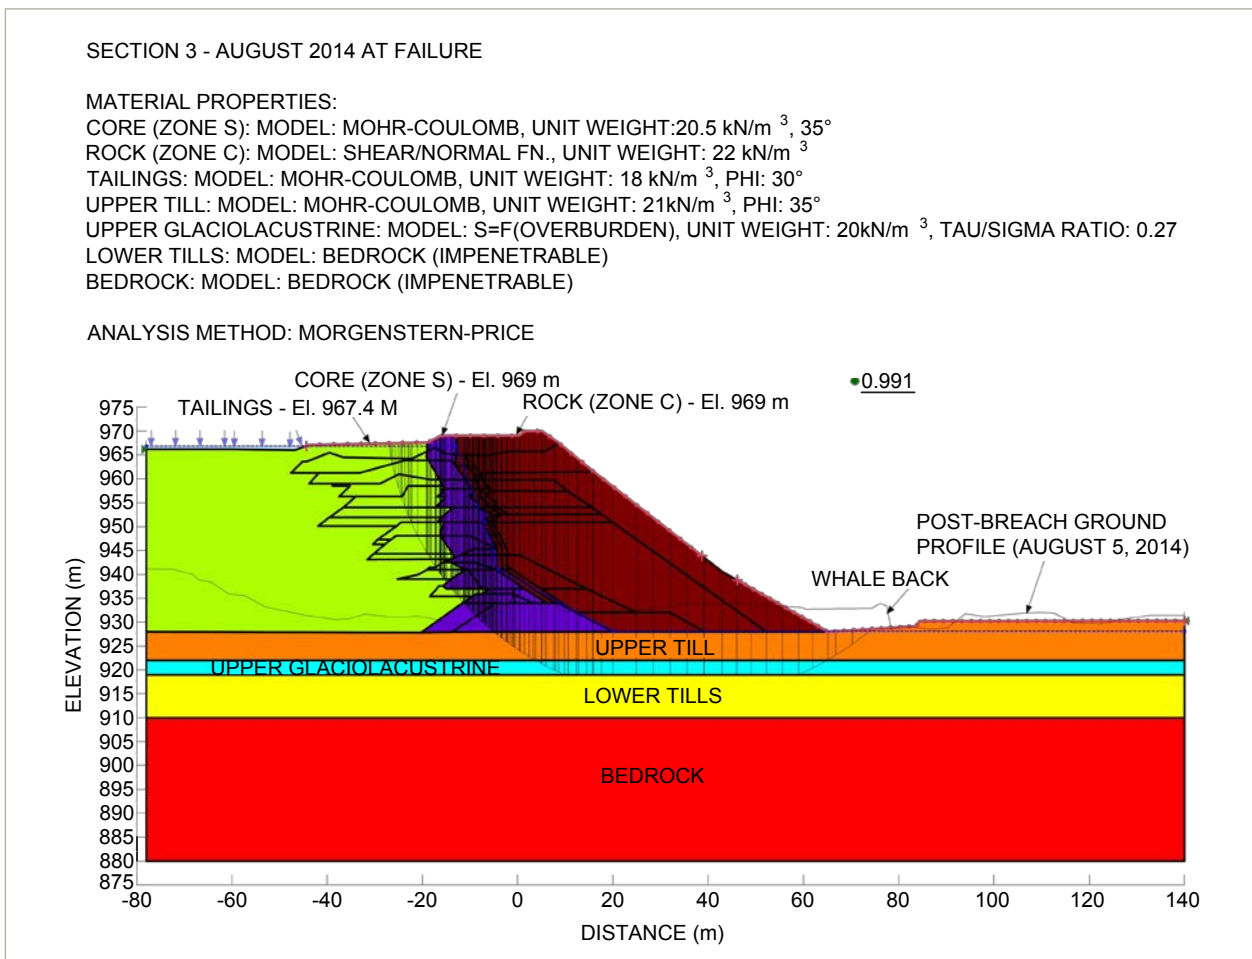
**FIGURE 6.2.1: DETAILED SECTION USED FOR LIMIT EQUILIBRIUM ANALYSIS (HIGH WATER TABLE, UNDRAINED STRENGTH RATIO 0.27)**

**Figure 6.2.1** presents the detailed section. It is based on the last LiDAR survey of the embankment prior to failure, a detailed reconstruction of the top of the structure and pond elevation based on construction inspector reports, and it includes a shallow excavation at the toe of the embankment as reported to the Panel. More details associated with the compilation of this and related sections are presented in Appendix H.

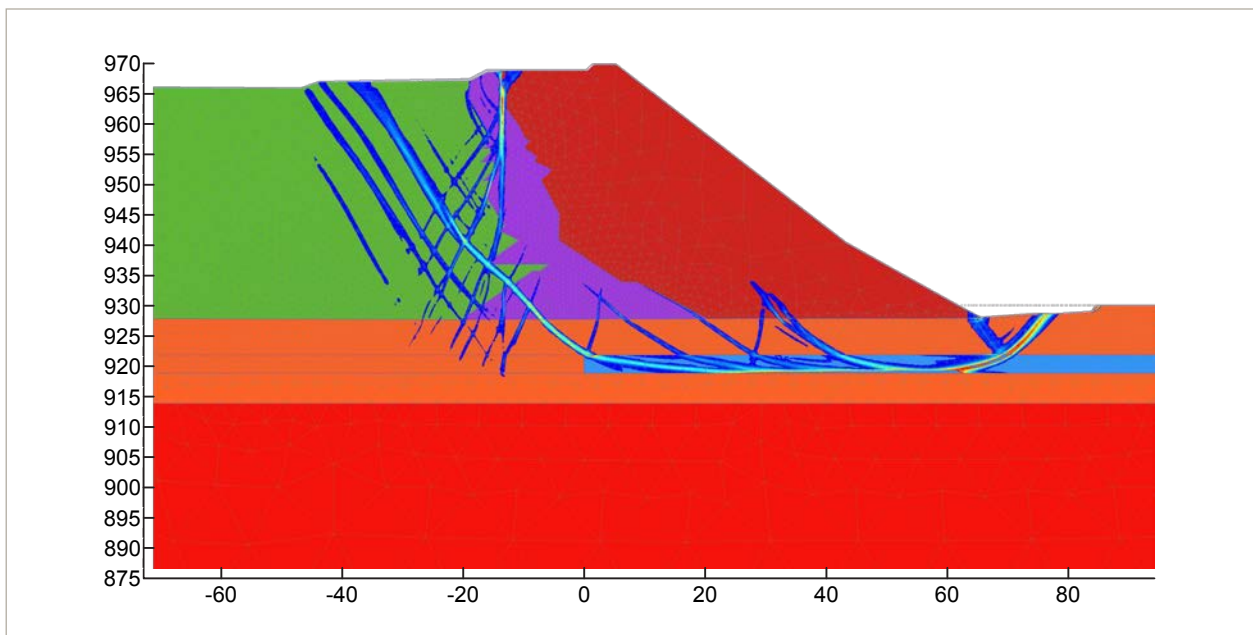
**FIGURE 6.2.3: PLAXIS MODEL AT COLLAPSE (UNDRAINED STRENGTH RATIO 0.29)**

**Figure 6.2.3** portrays the PLAXIS model at collapse. Prior to creating collapse, the model was constructed with essentially the same input parameters as used in the limit equilibrium analyses, except for the Upper GLU that is given a high strength to avoid yielding. The strength of the Upper GLU is then reduced until a deformation mechanism forms and the embankment collapses. This provides not only a measure of the strength of the Upper GLU at which failure occurs, but also an indication of the deformed shape arising from failure. In the model presented in **Figure 6.2.3**, collapse occurred at an undrained strength ratio of 0.29, which is to be compared with 0.27 calculated from the limit equilibrium analysis that incorporates the same boundary conditions. Lower undrained strength conditions would indicate significantly larger deformations. The figure also indicates the zones of localized strain that develop to facilitate motion. Variations of continuity of the Upper GLU with respect to this case yielded similar results.

Both the entry and exit of the failure surface in the foundation correspond closely with field observations summarized in **Figure C4.2.2** in Appendix C.

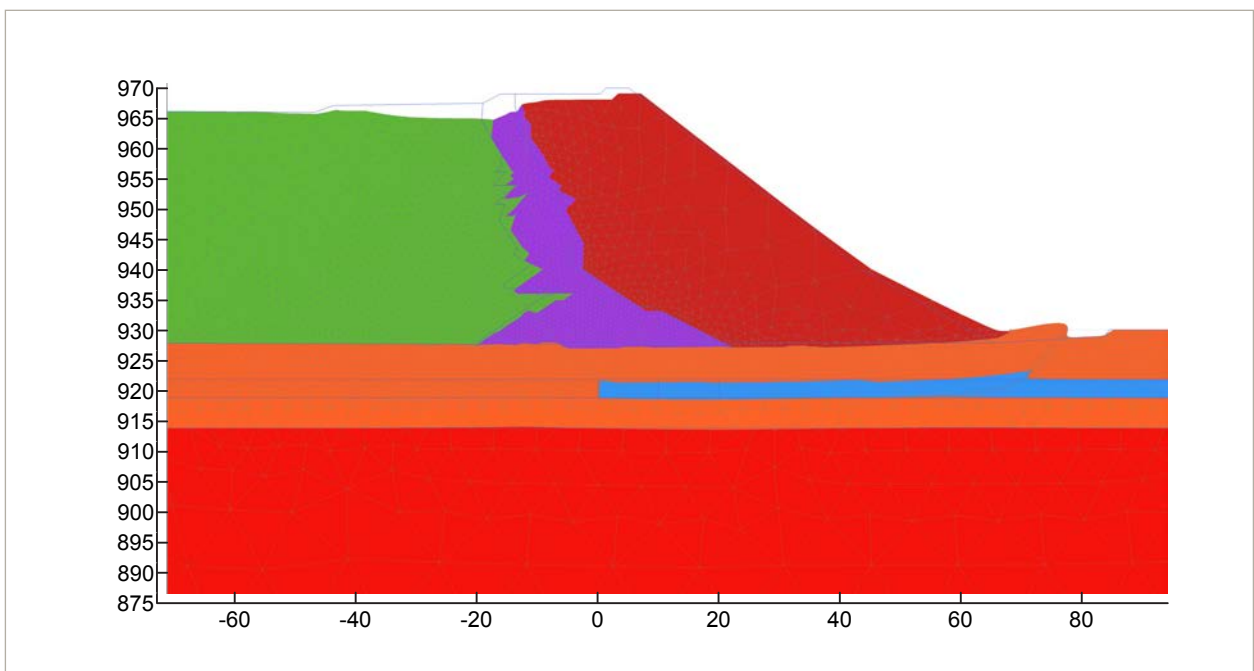
**FIGURE 6.2.4: SCALED-UP FIGURE 6.2.3 TO ILLUSTRATE DEFORMATIONS**

The PLAXIS analyses provide compelling support for the hypothesis that the movements of the Perimeter Embankment arose due to the undrained failure of the Upper GLU.

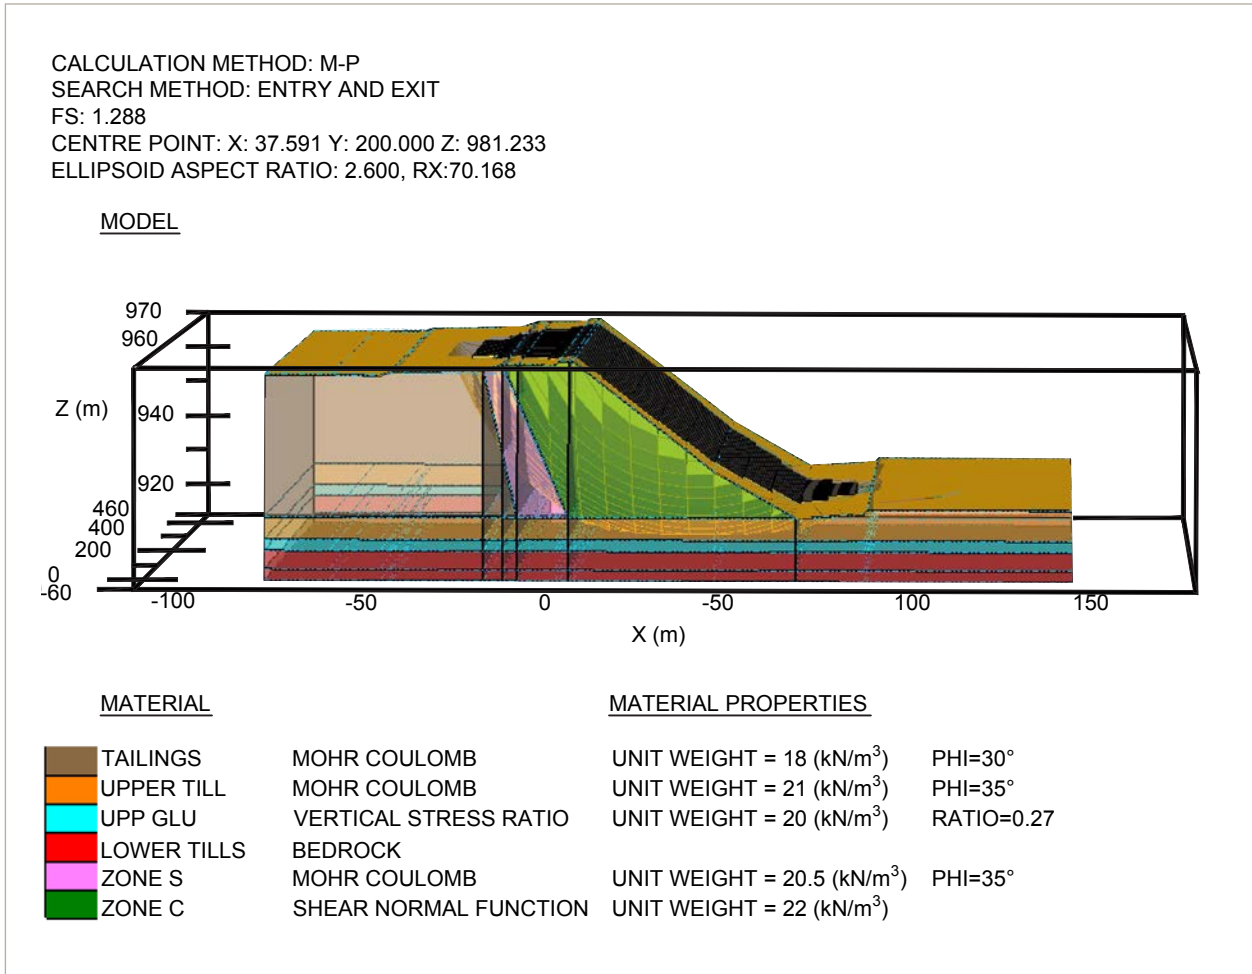
**FIGURE 6.2.5: 3-D LIMIT EQUILIBRIUM ANALYSIS (UNDRAINED STRENGTH RATIO 0.27, ASPECT RATIO 2.6, FS IS ABOUT 1.3)**

The length of the breach is relatively short compared to the height of the Perimeter Embankment at failure (~ 40 m). This is expressed as an Aspect Ratio (length/height) and is calculated to be 2.6. At this Aspect Ratio, three-dimensional restraints might be a significant factor influencing the analysis of the breach mechanism. At small Aspect Ratios, the side resistance acting on the potential moving mass increases in significance. This is ignored in the 2-D analyses described above, which are used routinely in design. Nevertheless, the Panel regarded it of value to assess three-dimensional considerations in order to fully explore the factors affecting the breach mechanism.

Three-dimensional limit equilibrium analyses have been conducted using the computer program SVSlope 3D, a widely accepted program for conducting such analyses. The geometry and boundary conditions are a three-dimensional extension of the case illustrated in **Figure 6.2.1**. All soil properties used in the 3-D analysis are the same as those employed in **Figure 6.2.1**.

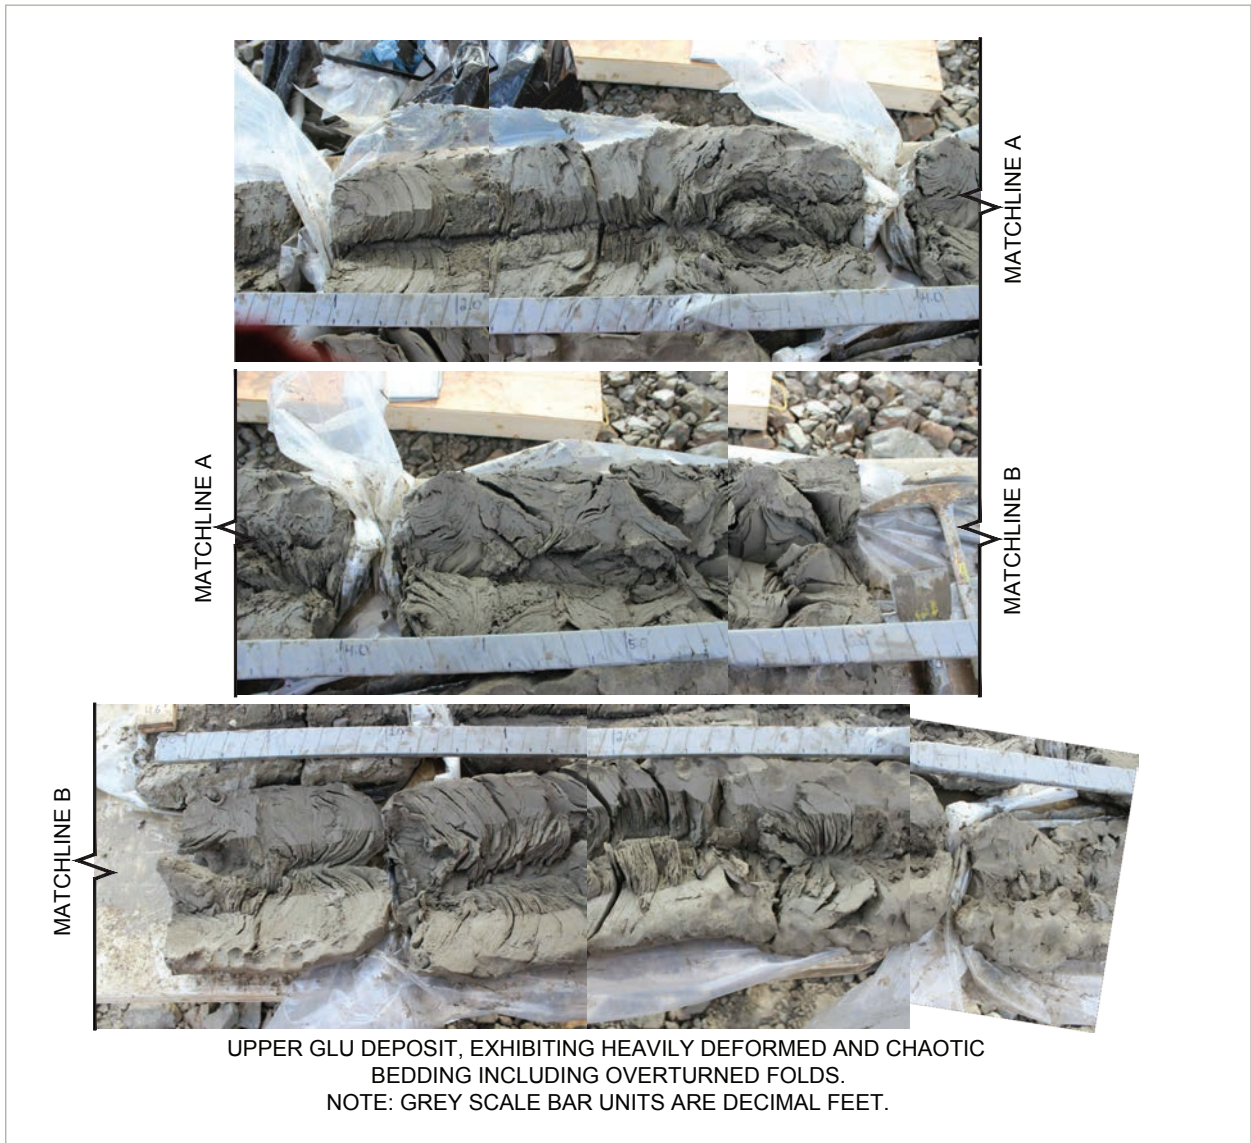
**FIGURE 6.2.6: TYPICAL SHEARING IN THE UPPER GLU**

As shown in Appendix D, Drawing D19, the sensitivities of the Upper GLU in the failure zone is about 1–3, based on CPT-measured tip resistances. Hence, as deformations developed in the Upper GLU, the available resistance reduced due to strain weakening and soil remoulding. Based on the observed sensitivity, it could have dropped to an undrained strength ratio of perhaps 0.13. Repeating 3-D limit analyses with these values yields an FS of about 1.1, which is close to collapse. Hence, as movements developed, the available resistance of the Upper GLU was reduced due to strain weakening to a degree that the three-dimensional restraints to movements at an Aspect Ratio of 2.6 were overcome. The idealizations involved in these 3-D analyses do not permit greater accuracy than expressed here. Going forward, a review of some of the assumed strength parameters that influenced the 3-D modelling and a more detailed representation of local geology that influence the 3-D results would be warranted. **Figure 6.2.6** displays visual evidence of the remolding processes that have occurred due to shearing of the GLU.

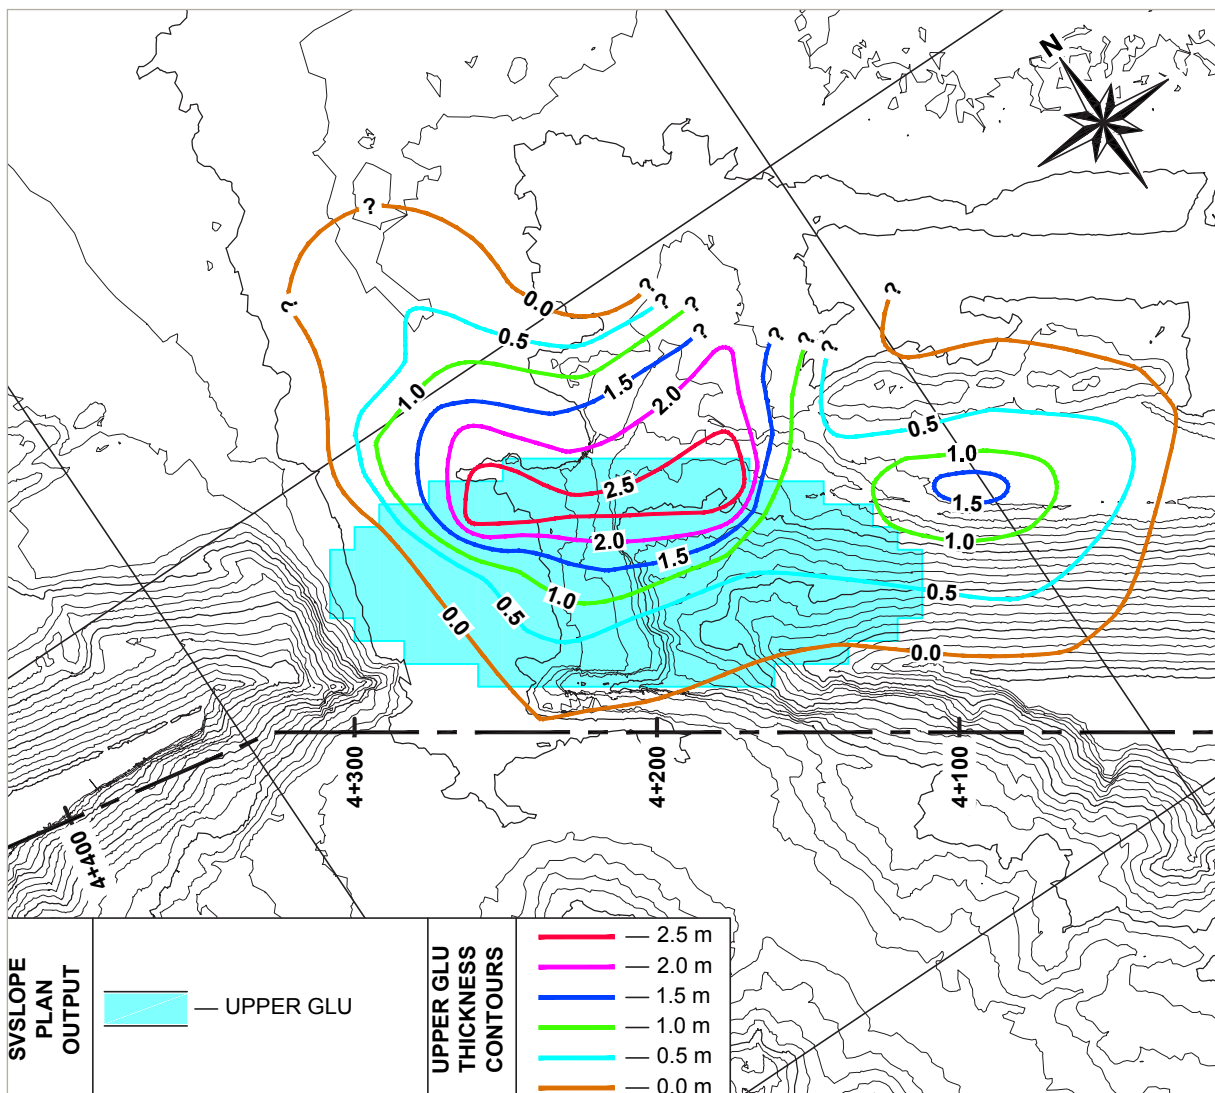
**FIGURE 6.2.7: COMPARISON OF THE 3-D ANALYSIS WITH THE THICKNESS CONTOURS OF THE UPPER GLU**

Additional support for the insight provided by the 3-D interpretation can be found by comparing the footprint of the 3-D analysis with the Aspect Ratio of 2.6 where it intersects the Upper GLU. The distribution of the thickness contours of Upper GLU is presented in **Figure 5.2.6**. This comparison is shown in **Figure 6.2.7**, which indicates a striking fit between the extent of the Upper GLU mobilized in the 3-D analysis (shown in cyan) with the extent of the deepest portion of the Upper GLU.

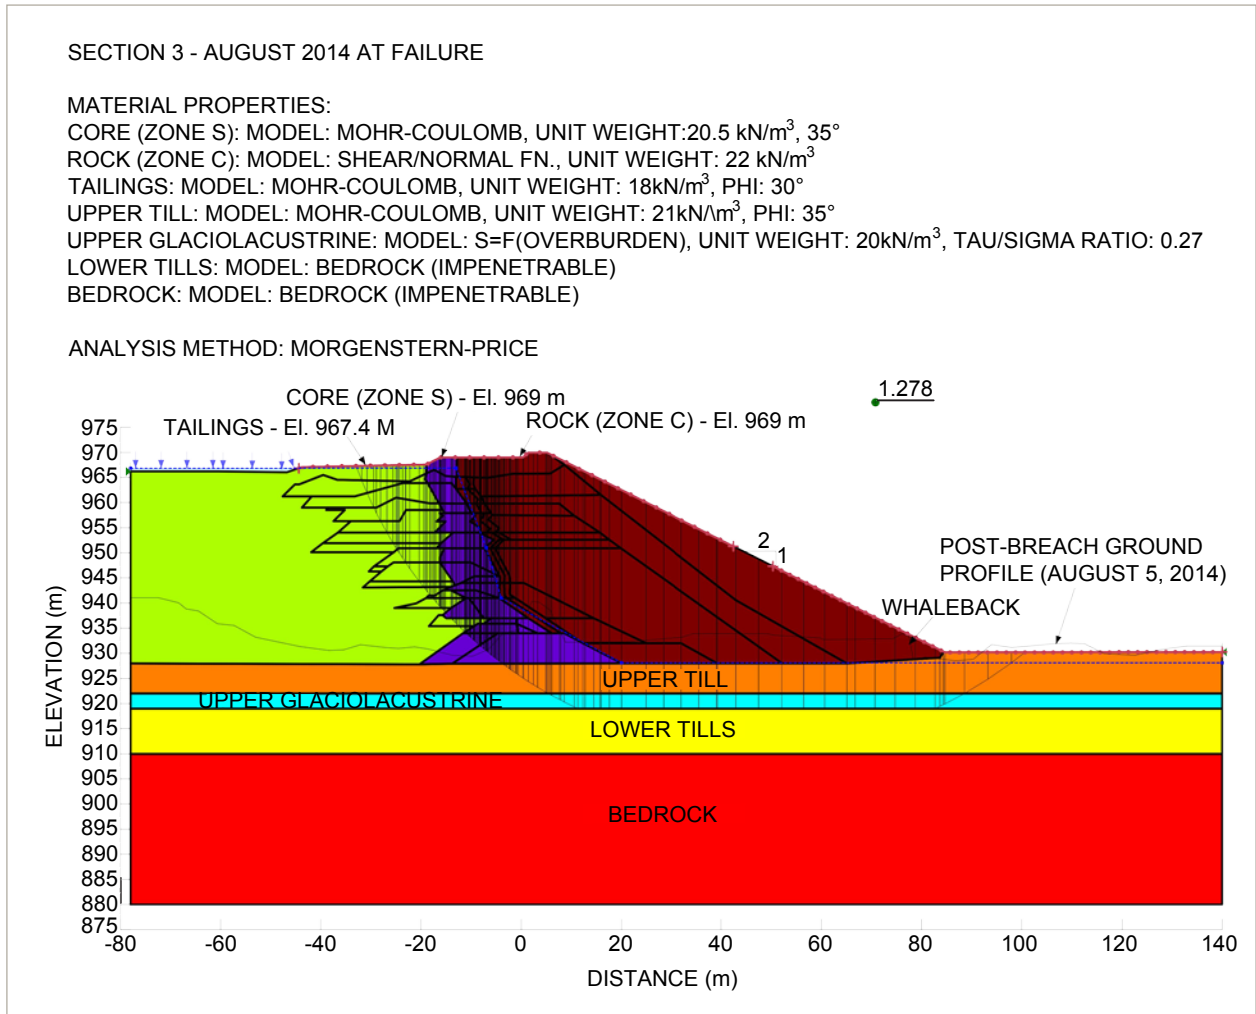
**FIGURE 6.5.3: PANEL'S STABILITY ANALYSIS FOR 2H:1V SLOPE WITH WIDENED CREST (FS = 1.28)**

slope began as an expedient temporary measure to facilitate construction during Stage 5. It became more or less permanent for subsequent phases, although concerns had been raised before the failure. The circumstances associated with the relative permanency of the 1.3H:1V slope are not well understood by the Panel. The complex issues that prevailed during construction are summarized in section 5.4. **Figure 6.5.3** indicates that, had the downstream slope incorporating the widened crest been flattened to 2H:1V, the FS would have been 1.28. This was close to the required value of 1.3, and the embankment would not have failed. Moreover, the slope of 2H:1V was required, in any case, to support reclamation and closure criteria.
